ATA-TR-64-5

ENGINEERING FLIGHT TEST

. CH-37B

ENGINEERING FLIGHT TEST OF THE CH-37B

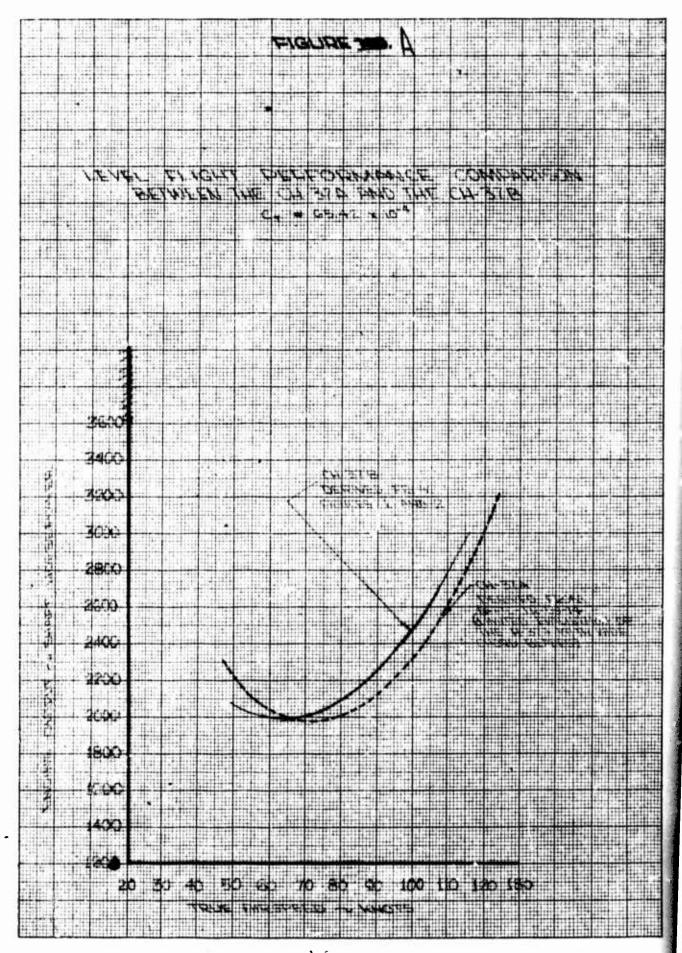
FIGURE A

A comparison of the CH-37B test results with the findings in the report AFFTC-TR-59-14, "Limited Evaluation of the H-37A Equipped with Wide Chord Blades", indicates a small difference in level flight performance. The shapes of the CH-37B speed-power curves are similar to those of the CH-37A. However, there is a displacement of the curve as illustrated in Figure A.

The CH-37B apparently required greater power at high airspeeds and less power at low airspeeds than the CH-37A. The displacement of the curve may be attributed to any or all of the following:

- Airspeed Calibration. The airspeed calibrations used during the two test programs differed. The CI-37A airspeed data were obtained from the standard ship's system while the CI-37B was evaluated with airspeeds obtained from a test (poom) system. The different position errors from the calibrations resulted in CH-37A calibrated airspeeds which were generally 1 to 2 knots higher.

- (b) Puel Flow. The Ci-37B evaluation was conducted with relatively high time engines (approximately 150 and 350 hours), and carburetors which had not been flow checked. An analysis of the fuel flow data shows that for the same horsepower output, these engines required a much greater fuel flow than the engines used in the Ci-37A test aircraft.

- (c) Method of Measuring Power. The engine power data for this report was obtained by using the manufacturers engine performance curves (power chart). The Cli-37A power was determined from torquemeter data.

- (d) Drag. Drag, while probably the least likely cause of the power-airspeed differential, should nevertheless be considered. The external configuration changes made to the CH-37A which could create a difference in drag are:

Consideration of the above indicates that the actual performance difference between the two configurations if less than 5 percent. Thus, no changes in the Operator's Manual are necessary, (Reference MIL-M-7700A, Paragraph 3.1.2.12.2; Changes will be necessary if alternate configurations result in a performance variation of more than 5 percent).

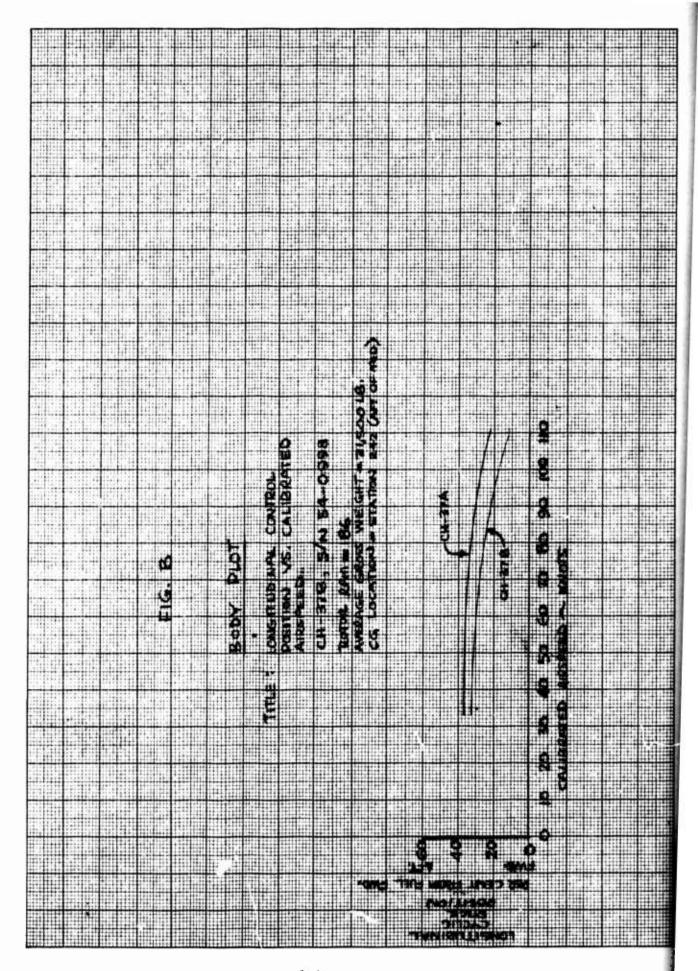
FIGURE B

Longitudinal speed stability was determined to be positive for all airspeeds above 45 knots at all flight conditions. There were no objectionable discontinuities and the speed stability became more positive as airspeed was increased. Qualitative pilot comments indicated that the static speed stability characteristics were the same with the Automatic Stabilization Equipment (ASE) both "on" and "off". Figure B compares the CH-37A and CH-37B longitudinal control positions as a function of calibrated airspeed.

The CH-37B required an average of seven percent more forward longitudinal cyclic control and the speed stability gradient became more positive as the airspeed was increased. This forward control position and the more positive stability was attributed to the greater moment created by the new stabilizer location. Qualitatively, there was no detectable difference in static longitudinal stability between the Ci-37A and the Ci-37B.

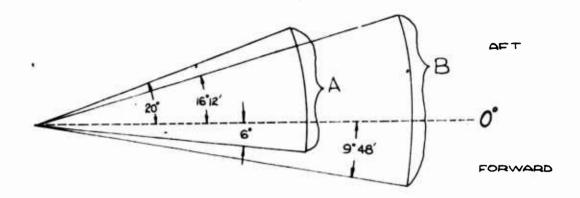
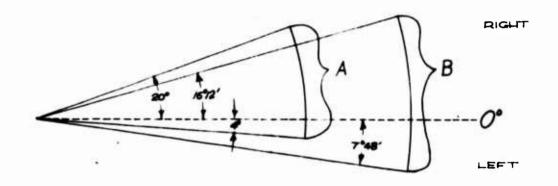
FIGURE C

A-Blade pitch variation of the Cl-37A B-Blade pitch variation of the Cl-37B

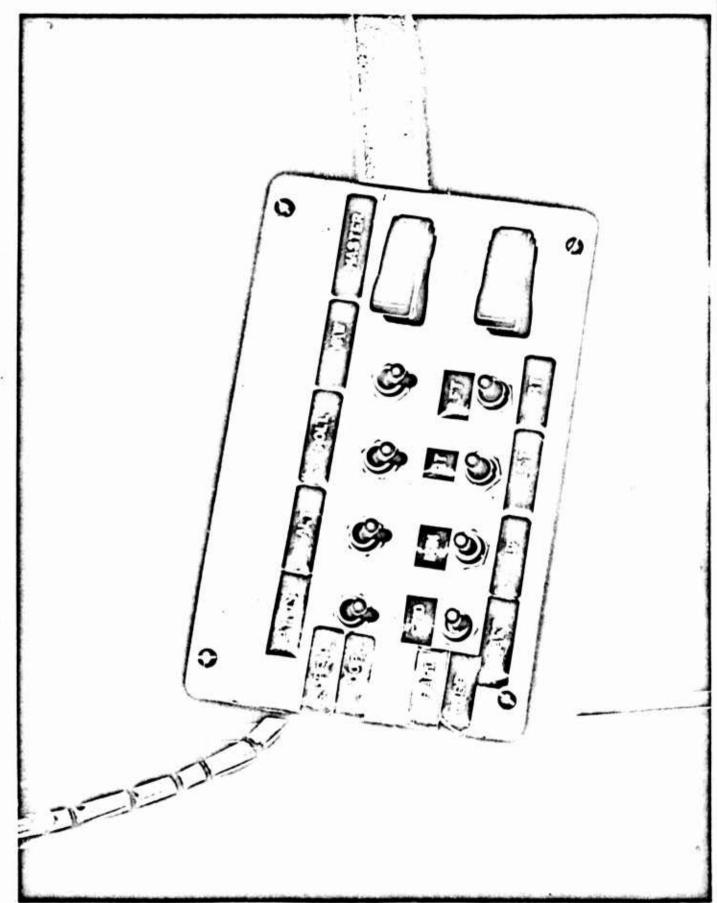
Tests were conducted to determine the aircraft's reaction to an ASE failure and the pilot effort required to control this reaction. The two types of failures analyzed were hard-overs and feedback circuit failures (oscillating hard-overs). A remote panel was provided by the aircraft manufacturer for the purpose of simulating the desired type of failure. This simulator panel is illustrated in Figure D. (Page 1.18)

From the simulator panel results it was found that the initial motion was in the same direction as the control movement which resulted from the failure. With the controls fixed the reaction was usually a long period, lightly damped oscillation. The only time it was necessary for the pilot to initiate immediate recovery was following a forward cyclic failure at high speed. In this case the motion was a divergent pitch down and recovery was initiated two and one-half seconds after the failure. Recovery was accomplished without excessive control inputs and before extreme attitudes resulted. When an immediate recovery was initiated the trim attitude could be maintained with only small corrections. Time history illustrations of these results are presented in Figures No. 60 through 68, Part II.

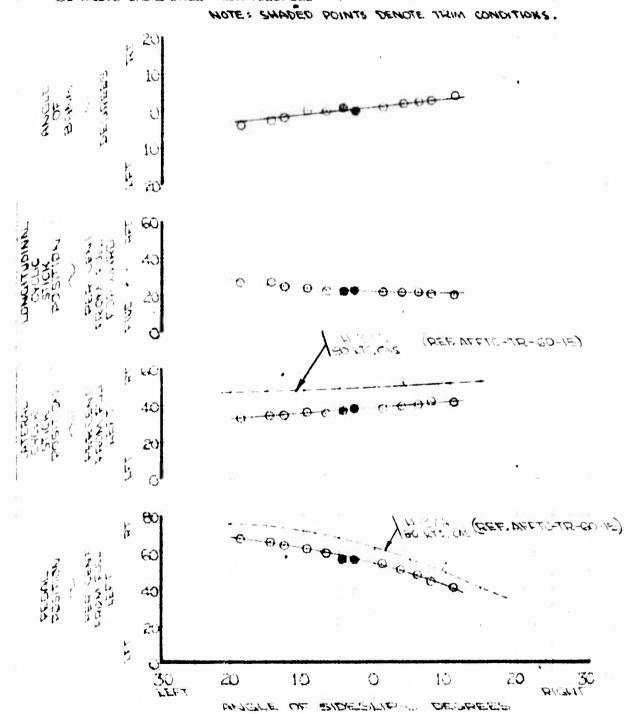
FIGURE NO. 11

STATIC DIRECTIONAL STABILITY CH-37B. LISA. S/N 54.0998

have a significant influence on the static directional stability. Extrapolation of the test data indicated that at least a ten percent control position margin existed for stabilized sideslip angles of 45 degrees at low speeds and 15 degrees at high speeds.

The static directional stability in autorotation was determined to be weakly positive for airspeeds of 42 to 57 knots with only 0.16 inches of pedal input required to change the sideslip angle from 15 degrees left to 15 degrees right. Maintaining a stabilized sideslip angle in autorotation was extremely difficult. A "wallowing" motion was experienced and directional control inputs had little effect on yaw attitude. These tests results were similar to those reported during the CH-37A tests. As in the level flight case, no significant difference was noted between the ASE "on" and "off" data, however, qualitative pilot comments indicated that stability was improved with the ASE operative and the directional flying qualities were better. Sufficient directional control was available to produce sideslip angles similar to those obtained in level flight.

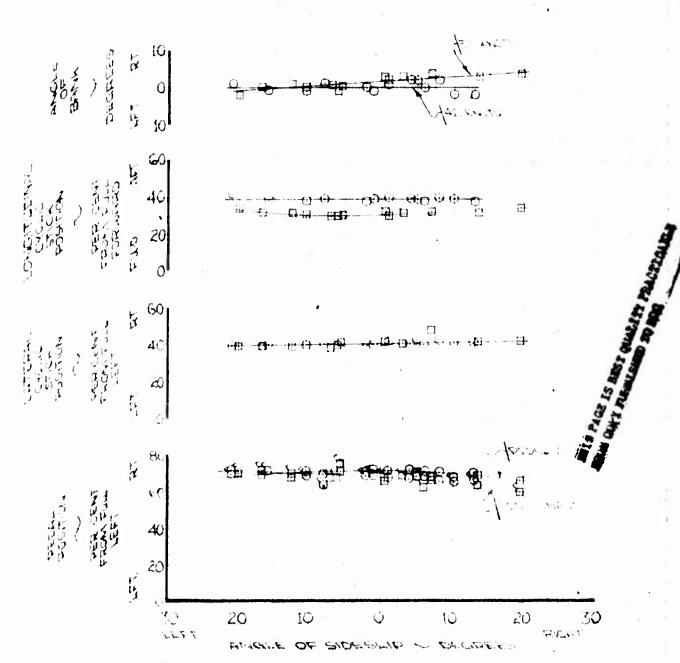
NOTE FLAGGED SAMBOLS DENOTE TOTAL PEDAL IMPUT WHICH IS PEDAL FRONTION PLUS PEDAL MSE IMPUT

DYNAMIC STABILITY

Little difference in dynamic stability was noted between the CH-37A and the CH-37B with the ASE "off". In all flight regimes a right pedal input resulted in a turn to the right with an oscillation about the yaw axis while left pedal pulses created an oscillation about the trim axis with no heading change. Yaw rates from the oscillations were high but the relatively long time required to reach maximum allowed the pilot to recover without difficulty. The high tail rotor location resulted in an initial small adverse lateral-directional coupling caused by changes in the tail rotor thrust. This coupling was prevalent at both low and high airspeeds. An initial nose-up pitching motion followed a left pedal pulse during hovering flight. In all other conditions, the helicopter pitched nose-down after the directional input. Ground effect and translation influenced motion about the pitch axis when conducting hovering stability tests.

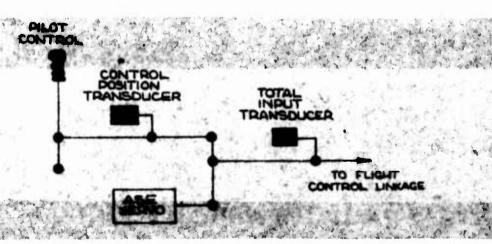
FIGURE B

The effect of the Automatic Stabilization Equipment (ASE) on the total input was recorded through use of a pickup located directly behind the ASE system. This instrumentation feature made it possible to isolate the total input (which includes the ASE input) from the pilot input. A simplified illustration of this is presented in Figure E.

(Minor movements in control position that are not evident from the total input position pickup can be attributed to "slop" in the mechanical and electrical linkages located between the control position pickup and the total input pickup.)
